FINAL  
FOUNDATION  
REPORT

COMPLETION OF EMBANKMENT  
OUTLET WORKS AND SPILLWAY  
COOPER LAKE  
SULPHUR RIVER, TEXAS

CORPS OF ENGINEERS  
FORT WORTH DISTRICT, TEXAS

MAY 1992

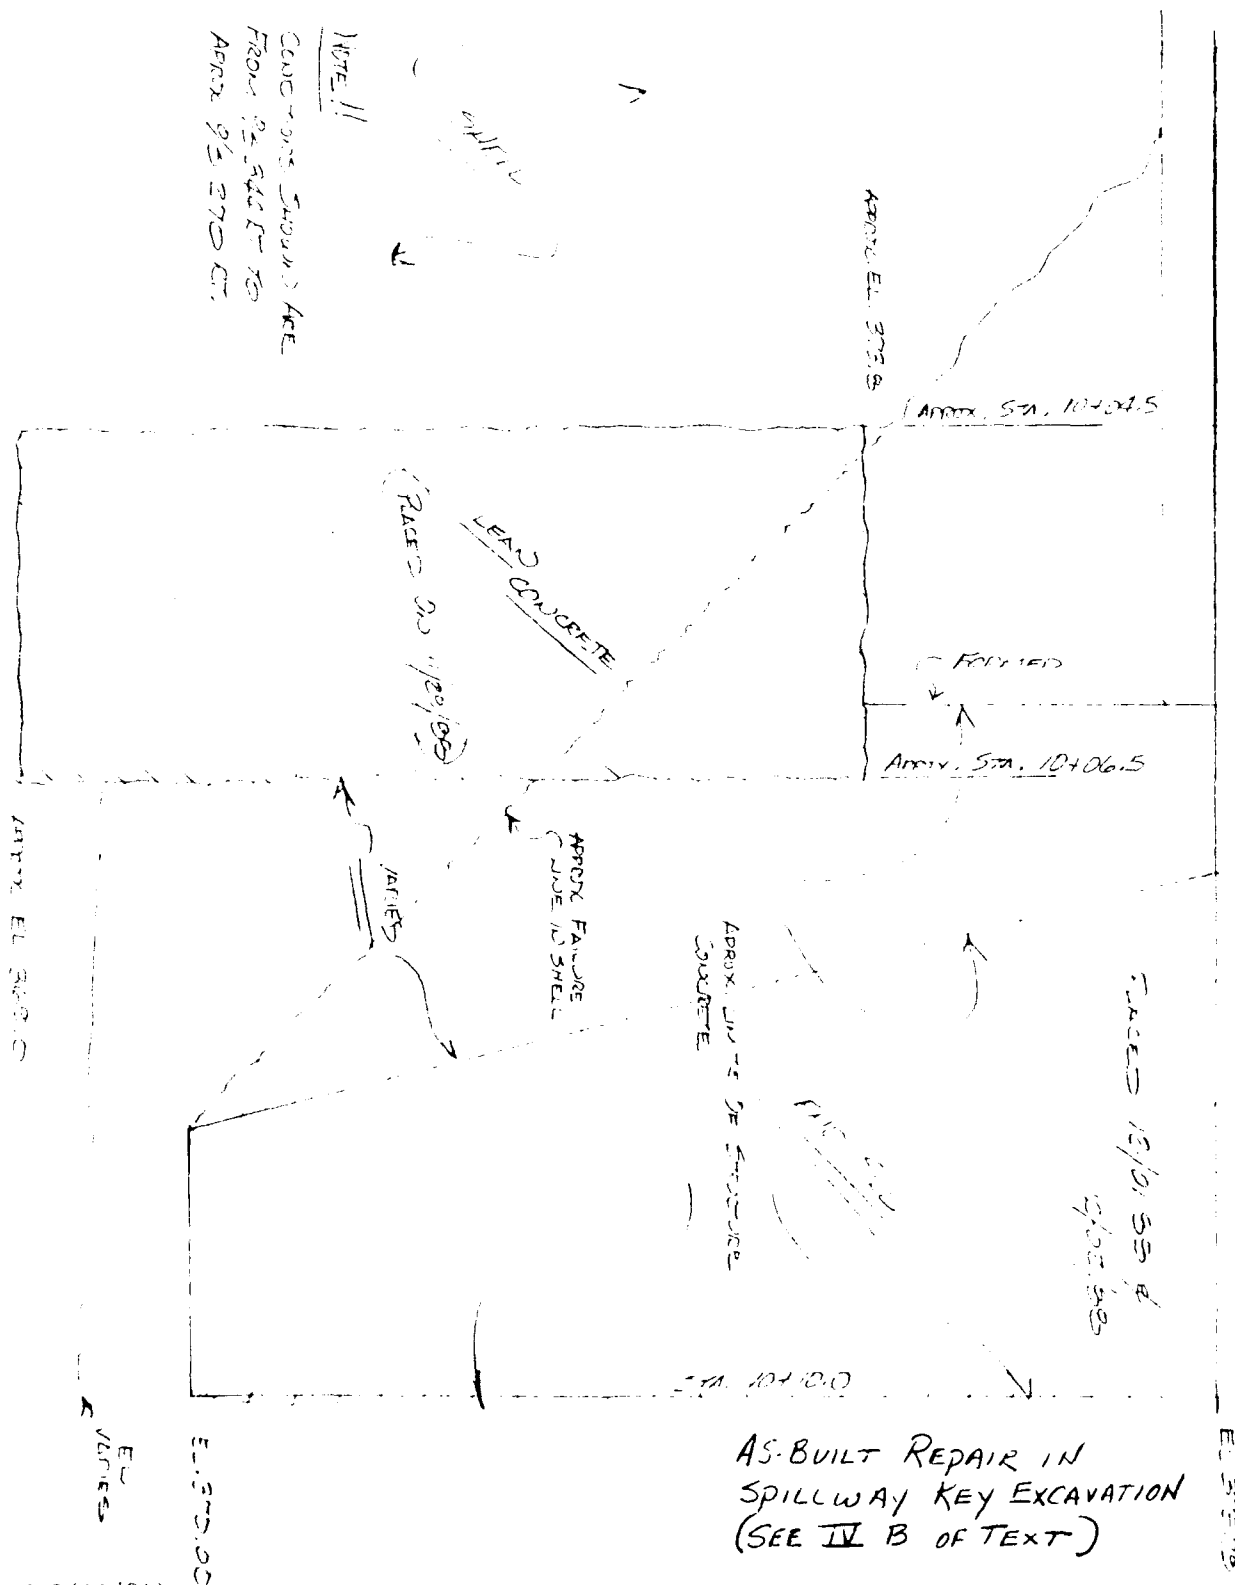
the deep inspection trench between local station 1+99.5 and local station 8+99.5 is to the west (toward the valley) at the rate of 1.55 feet vertically per 100 feet horizontally. The average component of dip along the centerline of the spillway between the weir and the deep inspection trench is upstream at 0.9 feet vertically per 100 feet horizontally. Similarly, though at a much lower elevation, the component of structural dip along the conduit foundation between station 76+40.5 and station 78+43.5 is upstream at the rate of 0.13 feet vertically per 100 feet horizontally on the right side of the conduit and 0.24 feet vertically per 100 feet horizontally upstream on the left side of the conduit. But the centerline of the spillway and the centerline of the outlet works are not parallel and can be seen to converge downstream at an angle of 10.8 degrees (see Plate 3). Taken together, these data suggest that the direction of average local dip of the bedrock and residual soils in this fault block is westward and slightly upstream along the embankment alignment as it crosses the spillway. Very few fractures were mapped in the foundation of the chute and stilling basin of the outlet works. None were mapped in the approach, gate tower, or conduit structure foundations. See Plates 30, 31, and 32 for the outlet works foundation. Quite a few fractures were mapped in the foundation of the spillway. The preponderance of them were located in the stilling basin and in the lower slopes of the chute where the shale has the lowest sand content of any excavated, unweathered material. Shale in this portion of the spillway appeared to have had some low-grade cleavage developed within it. While quite a number of the fractures mapped obviously existed prior to excavation, quite a number also appeared to have developed from using a scraping tool (a backhoe) for fine grading the foundation surface of the cleavable shale. These fractures did not extend to any significant depth into the shale. See Plate 33 for the foundation of the spillway. The most significant fracturing from an engineering standpoint seemed to be those fractures encountered during initial excavation of the right end of the cutoff key at the downstream end of the spillway slab. At this location several slices of foundation shale failed into the key excavation very shortly after it was excavated with a toothed ditching machine (Vermeer T-650). In all instances the shale failed on what appeared to be slickensided cleavage surfaces dipping downstream more gently than the steep upstream 4V on 1H slope of the key. Even though the fractures were not apparent when the key was first excavated, it seems likely that they existed prior to that time because of the slickensiding on the failure surfaces (pre-failed shale). One failure occurred immediately following excavation. A second failure consisting of several thin slices of shale occurred after the earlier thicker failure slices blocking the excavation had been cleared and preparations were being made to place structural concrete. The failure section was between offset 270 right and offset 344 right of the spillway centerline. The downstream vertical surface of the cutoff key is at spillway station 10+10. The contractor (Martin K. Eby Co.) repaired the excavation and placed structural concrete as indicated in his sketch (Figure 1).
